**How to prevent
water leaks
on Type 914 – 914/6 vehicles**

**VOLKSWAGENWERK AKTIENGESELLSCHAFT · WOLFSBURG
DR.-ING. h. c. F. PORSCHE KG · STUTTGART-ZUFFENHAUSEN**

PROCEDURES TO CORRECT AND PREVENT WATER LEAKAGE INTO PASSENGER,
FUEL TANK, FRONT AND REAR LUGGAGE COMPARTMENTS.

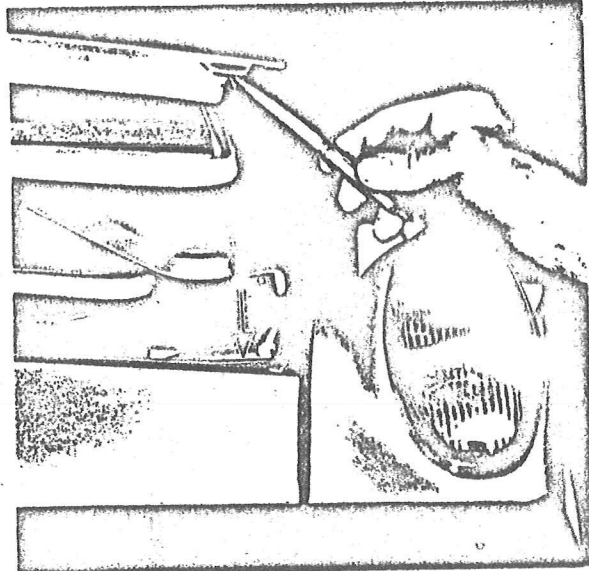
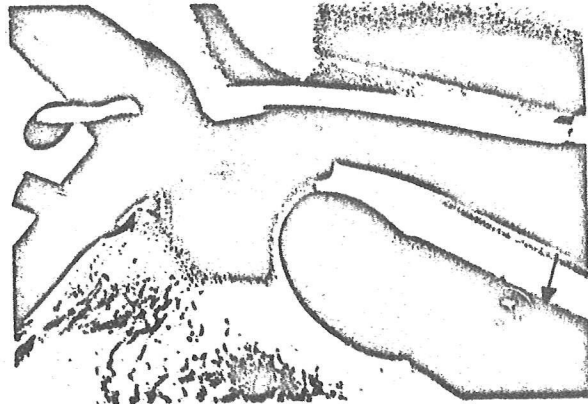
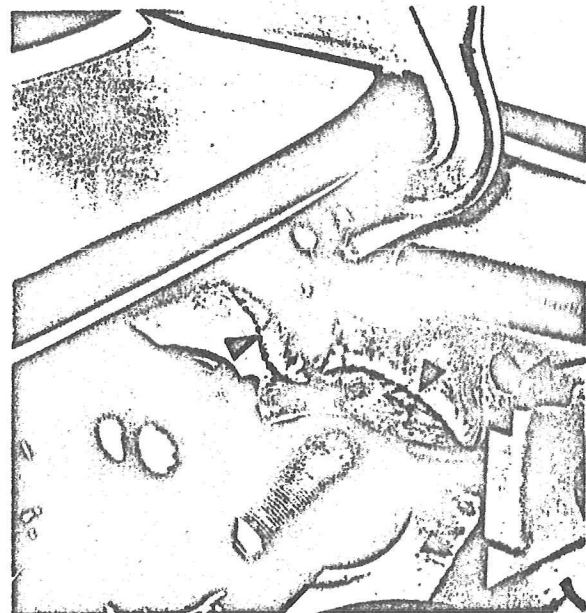
Item 1

Front luggage compartment leaking.
Inadequate pressure of lid seal or partial vacuum inside compartment allows water to enter.

- a. Examine lid seal, if necessary re-attach seal carefully with adhesive or re-align metal frame. Check left and right areas (see arrow) with special care.

- b. Install rubber sealing washers under the two front apron fastening bolts in the lock bulkhead. The slots must be covered (see illustration).

- c. Check luggage compartment floor and install rubber grommets in the paint drain holes if missing.

- d. Examine spot weld flanges on lock bulkhead and wheel housings for leaks. If necessary seal with National 5100 sealer.

- e. Look for leakage at the side spot weld seams between wheel housing and bulkhead to fuel tank compartment at left and right (see illustration). Water may be penetrating into the passenger compartment. Seal affected areas with sealing compound.

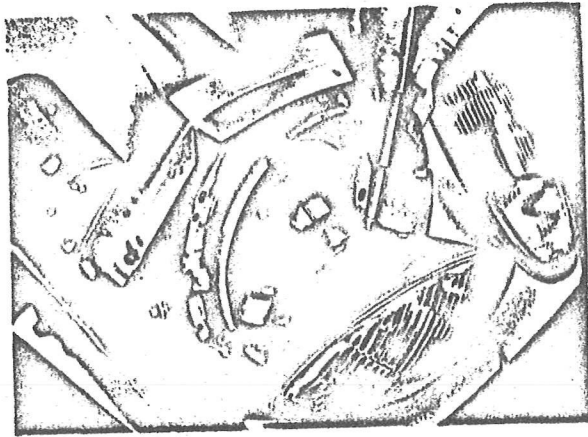
Item 2

Water entering at headlights.

Remove the headlights (see Workshop Manual Group 9, 3.2-2/1).
Check that rubber cap is correctly located on reflector. Prevent possible leaks between glass and reflector with 'UHU-hart'.
Route the cable so that it is bent downward before reaching the plugs. This will prevent moisture from reaching the plugs.

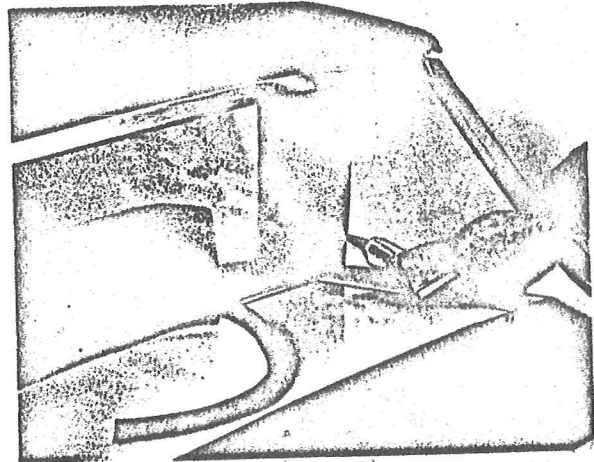
Item 4

Lower corners of rear window leaking.
Water entering between the rear bulkhead and its lining.

Partly pull away the rubber seal strip from the flange between the engine compartment and the glass. Seal the glass at the rear face and press the seal strip back into position.

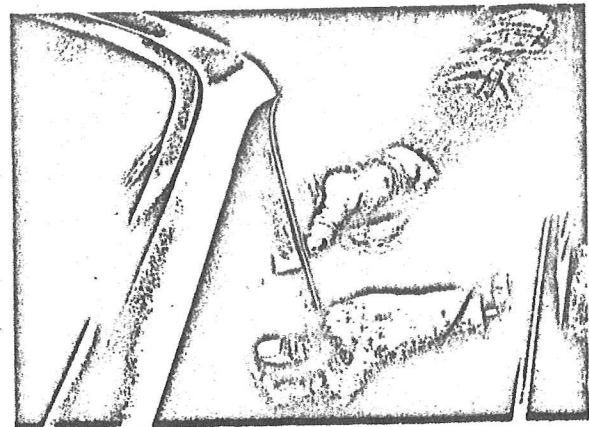
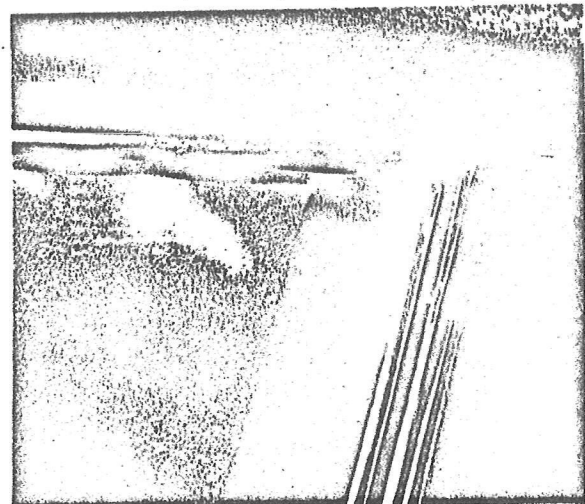
- b. Windshield pillar seal leaking. Water entering between pillar and clamping strip and at the butt joint between the windshield surround seal and the roof side seal.

Pull the rubber seal out of the clamping strip. Unscrew the clamping strip from the windshield pillar.

Attach Terostat strip under the curved top section of the clamping strip, and coat the entire length of the strip on the inside face with Bostik 292 Universal adhesive. Re-attach the clamping strip and sealing strip. Align the door window guide correctly. The butt end should make a good seal under pressure with the roof side seal.

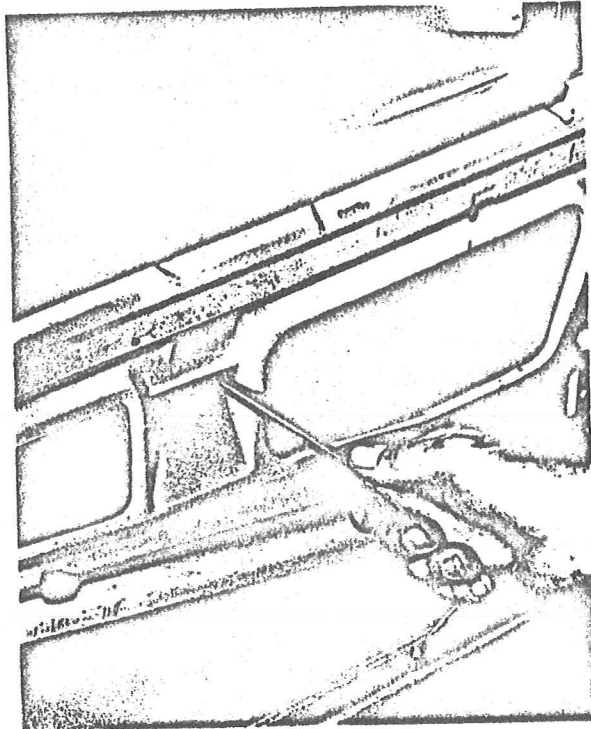
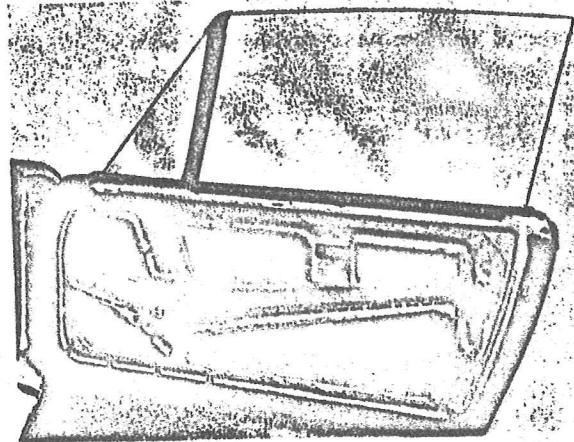
b. Door seal leaking.

Water enters under the door seal at the upper edge of the side member and penetrates the interior of the vehicle.

Take off the door trim panel. Loosen the bottom half of the plastic film over the complete width of the door and up to about half the height of the panel. Then cut a strip of plastic film about 25 cm (10 in.) wide and attach the top to the inner door panel. Trim the film and allow it to hang down through the cutouts in the door so that any moisture is directed through the water drain holes to the outside of the car. Replace damaged grommets (see picture) and re-attach the original plastic film carefully with adhesive.

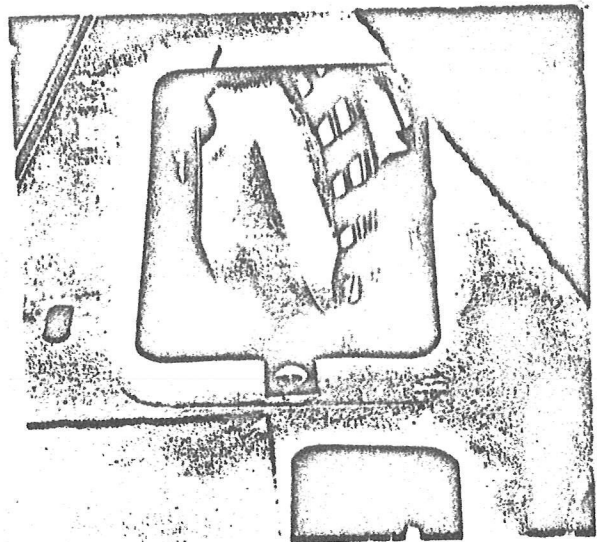
b. Front of center tunnel - water entering.

Remove the pedal floor board. Fold back the center tunnel carpet. Take off the cover panel from the tunnel. Seal the holes for the brake and fuel lines with National 5100 sealer. Apply also to the brake line hole from underneath the car.

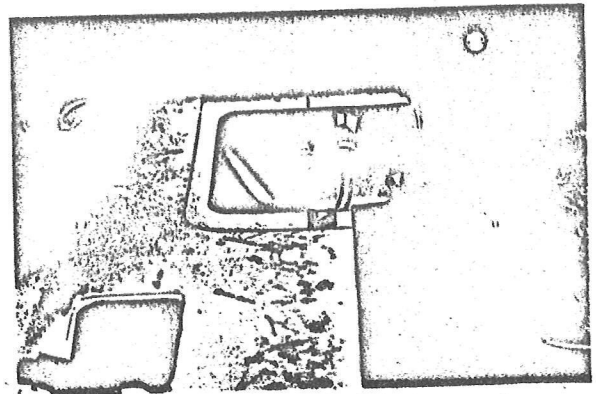
c. Rear of center tunnel leaking - on 914/6
Water entering car's interior through center tunnel.

Examine the floor panel and base of rear bulkhead near the 914/6 engine mounting, and carefully coat with National 5100 sealer. Remove the console and cover from the center tunnel and also apply the National 5100 sealer to the inside face.

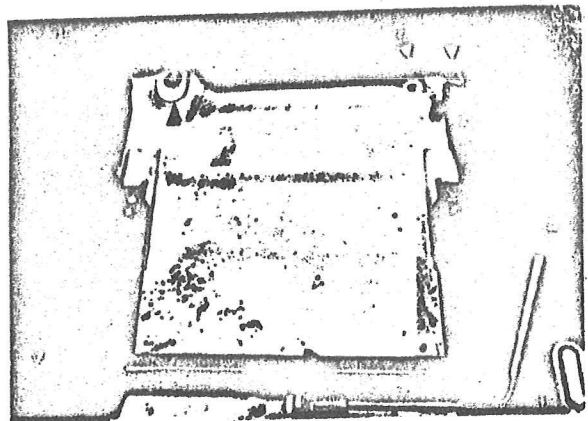
e. Water in tunnel.

Drill a water drain hole at the lowest point on the floor panel and install a rubber vent grommet.

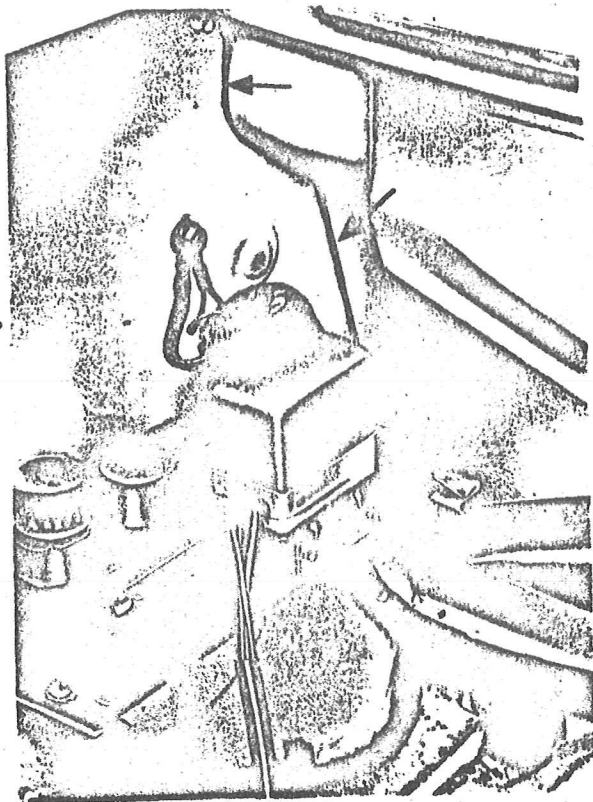
Water entering at rear bulkhead.

- a. Inspect the entire length of the rear bulkhead joint with the wheel housing inner panel from the engine side. If necessary apply National 5100 sealer. Carefully seal the Bowden cable for the engine compartment release. Seal the same area from the passenger compartment side.

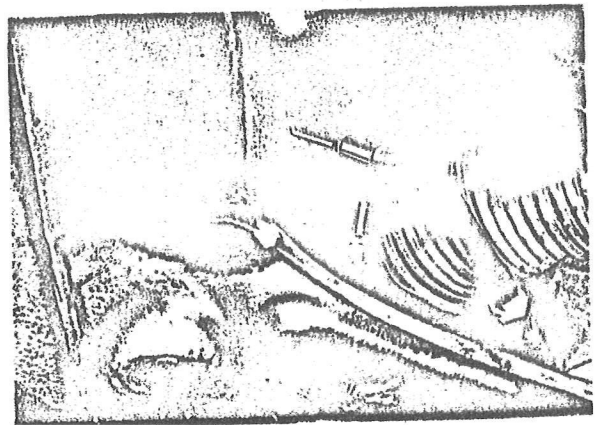
- c. Check around outer handbrake cable tube and lower part of bulkhead for leaks.

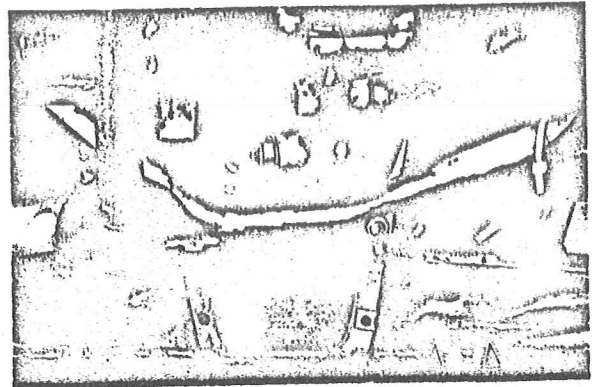
- e. Leakage at hole for fuel line, gearshift rod and speedometer shaft in lower section of rear bulkhead. Water entering passenger compartment.

Seal the grommets with sealing compound.

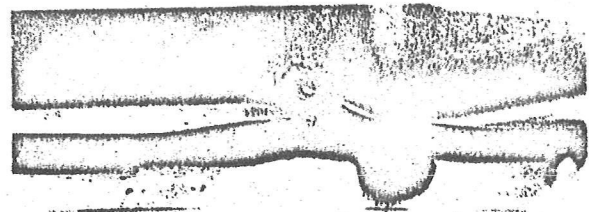
- a. Water drain funnel not correctly centered below water drip tray.

Bend funnel fastening at support.

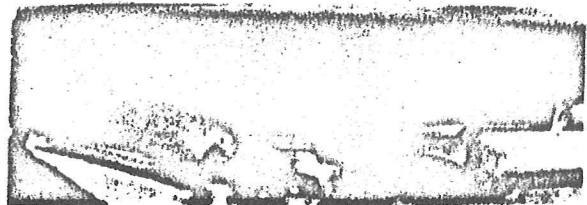
- b. Water entering tunnel and interior at point of cable harness division in engine compartment

Fill the junction above the rubber grommet with sealer and wrap with adhesive strip.

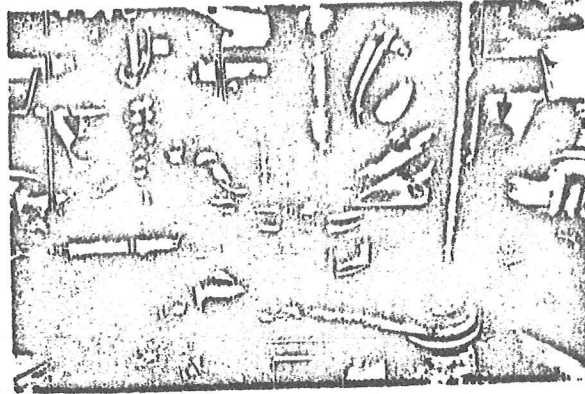
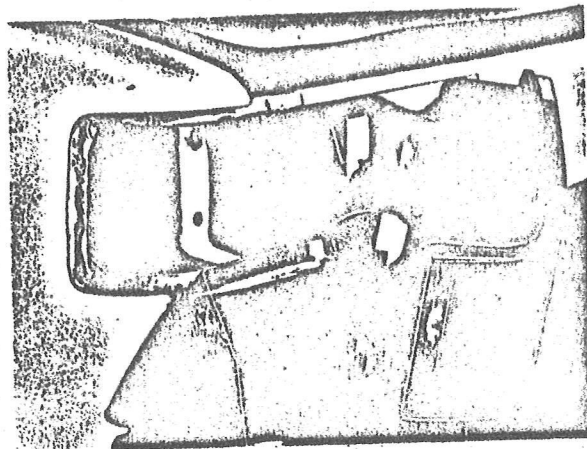
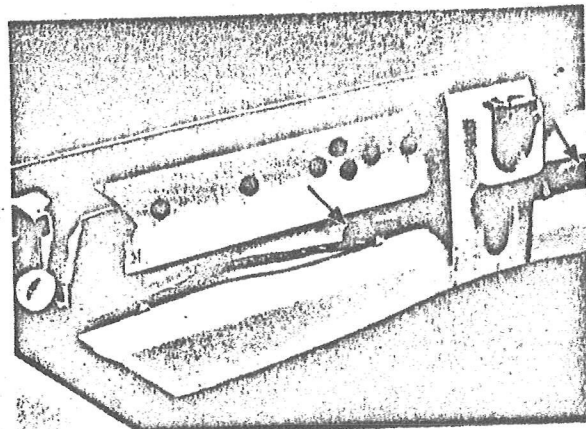
Rear luggage compartment - water entering; inadequate pressure of lid seal, partial vacuum in luggage compartment.

- a. Rear light assemblies leaking
Water entering between end panel of body and assembly housing and penetrating luggage compartment.

- b. Water entering the lamp assemblies themselves

- a. Inspect luggage compartment floor and panels connected to the wheels housings. Reseal where necessary.
- b. Close the holes in the cross member with plastic plugs 999, 703, 201, 40 (see illustration).
(Water entering through threaded connection for spare wheel).
- c. Rear shock absorber pans - leaking through to luggage compartment: apply National 5100 sealer to the shock absorber pans from the wheel side.

Remove the rear lights. Apply Terostat strip to the outer half of the sealing face on the end panel (half width) and re-install the rear lights.

Unscrew and remove the light assembly. Seal the lense gasket with Terostat strip as required. New gaskets installed from chassis number 470 290 4801

- c. Seal type insignia attachment points.
- d. Carefully seal the cable outlets through the end panel to the license plate lights with sealing compound
